Case Study

Baumer Ensures That Shampoo Bottles Are Correctly Sealed on High-Speed Packaging Line

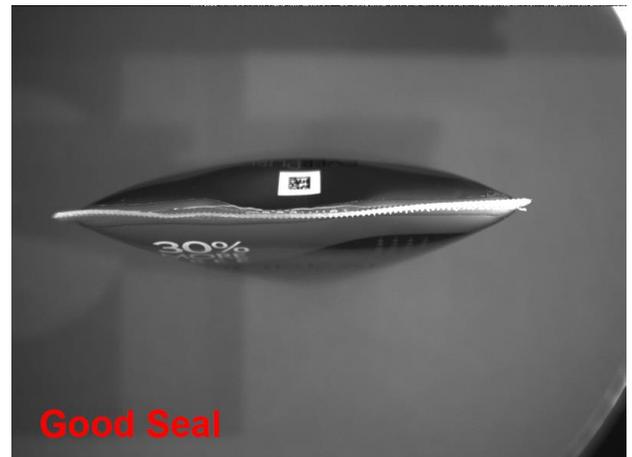
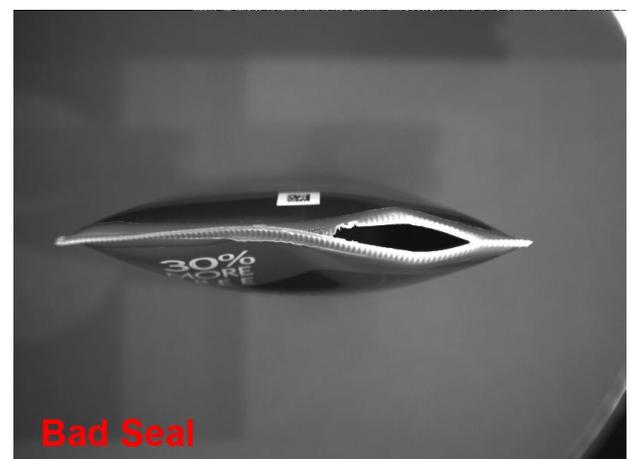
Baumer helped one leading shampoo brand retrofit its patchwork packaging inspection system into a high-speed imaging solution, with a VeriSens smart camera, the right illumination, and Baumer's award-winning vision software.

The job required Baumer to work within the constraints of the manufacturer's existing production line, in which shampoo tubes travel along a conveyor in custom trays that position the crimped end at the top of the tube. So the Design Team mounted a downward-facing camera about 6 inches above the production line to capture close-up images of each tube's crimped seal.

The team selected [a two-megapixel monochrome VeriSens camera](#) from Baumer for the job. The camera incorporates a 1600 x 1200-pixel CMOS sensor capable of performing up to 100 inspections per minute. An 8-mm lens captures crisp images of the seals.

Since open or poor-quality seals tend to appear darker in captured images, Baumer wanted to eliminate all natural shadows within the camera's field of view. Baumer recommended that the customer use a white conveyor belt to ensure that tubes were imaged against a pale background. It further eliminated shadows by positioning a 3-inch ring light 1.25 inches above the crimped ends of the tubes and slightly off axis to make proper seals appear bright in the images. This ensured that bad seals would be the only dark patches in the images.
