## Case Study

### Baumer ensures that shampoo bottles are correctly sealed on high-speed packaging line

*The Vision Design team's cost-effective, intuitive vision solution aims to help shampoo packager verify that bottles are correctly sealed without working up a lather.*

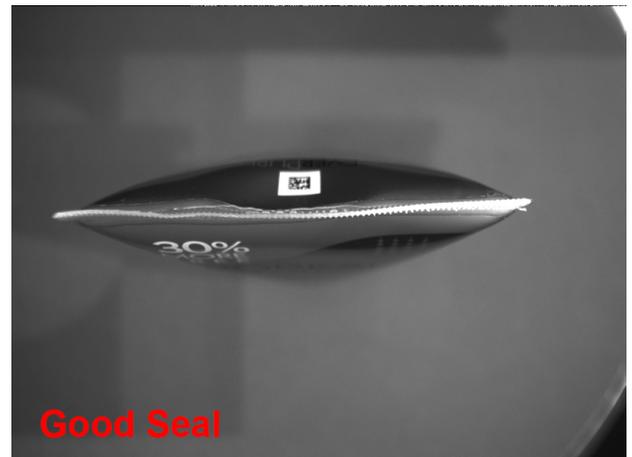
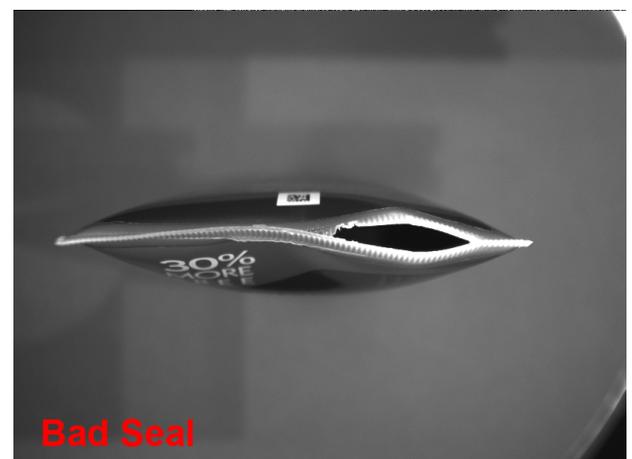
*Baumer helped one leading shampoo brand retrofit its patchwork packaging inspection system into a high-speed imaging solution, with a VeriSens® smart vision sensor, the right illumination, and VeriSens® Application Suite.*

The job required Baumer to work within the constraints of the manufacturer's existing production line, in which shampoo tubes travel along a conveyor in custom trays that position the crimped end at the top of the tube. So the Design Team mounted a downward-facing vision sensor about 6 inches above the production line to capture close-up images of each tube's crimped seal.

The team selected a two-megapixel monochrome VeriSens® smart vision sensor from Baumer for the job. The smart vision sensor incorporates a 1600 x 1200-pixel CMOS sensor capable of performing up to 100 inspections per minute. An 8-mm lens captures crisp images of the seals.

Since open or poor-quality seals tend to appear darker in captured images, Baumer wanted to eliminate all natural shadows within the sensor's field of view. Baumer recommended that the customer use a white conveyor belt to ensure that tubes were imaged against a pale background. It further eliminated shadows by positioning a 3-inch ring light 1.25 inches above the crimped ends of the tubes and slightly off axis to make proper seals appear bright in the images. This ensured that bad seals would be the only dark patches in the images.
